F-4-66 Jacob Leatherman Farmstead Wolfsville Frederick County

Maryland Historical Trust State Historic Sites Inventory Form

Survey	No.	F-4-66
--------	-----	--------

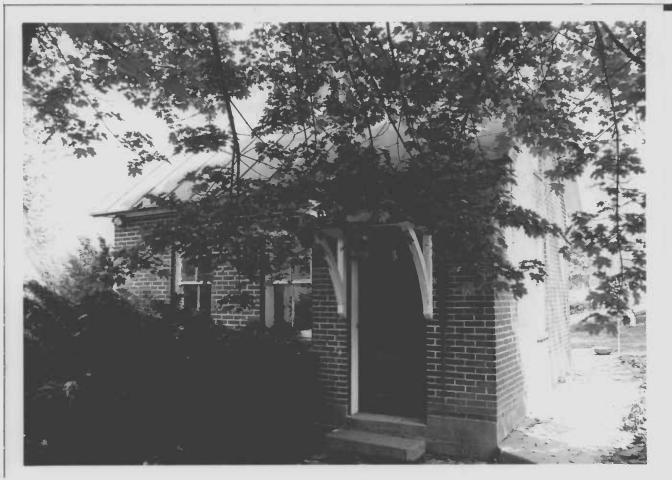
Butchering shed: The brick butchering shed is a one-story structure located east of the rear wing of the house. It has a rectangular plan with 2/2 windows and a standing seam metal gable roof. The door is a five-panel type located near the southwest corner under a bracketed hood. An exterior brick chimney is located on the north elevation. The butchering shed was also built during the 1920's.

1-4-66 Joseph Leatherman Fun stern Frank week Smooth Man La Mid. Store, Chearing Me. Mish. Butcher was shed , southwas ser asmer wine
